TRAIL WORTHY TACOMA

Steering fix, winch, and
37s for our SAS TRD

By Brian Cox

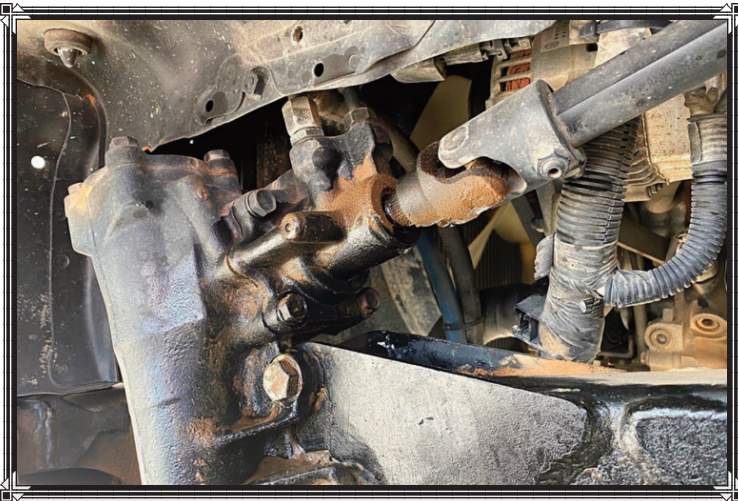
This seriously leaking steering box is the main reason we opted to make a few upgrades on the truck. The old steering box got us off the trail and home safely on its last outing, but continued use in this condition would be asking for trouble.

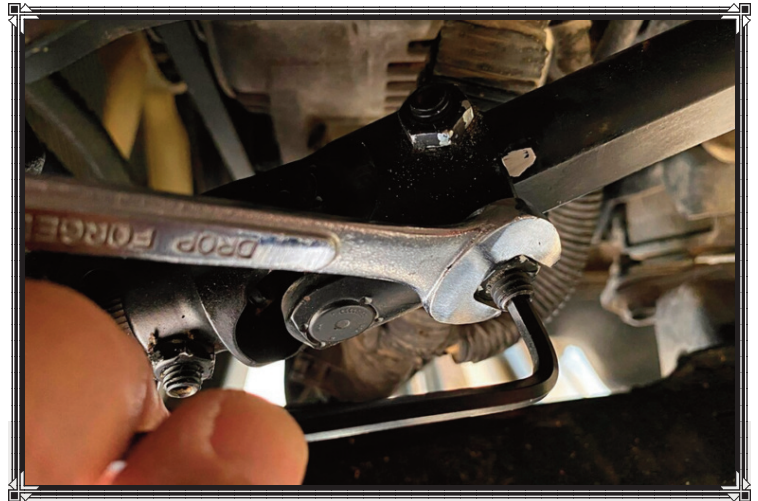
Our Toyota is equipped with a Borgeson steering shaft. We removed the set screws and the long pin/screw that goes all the way through the unit. We then slid the steering shaft off of the power steering box sector shaft.

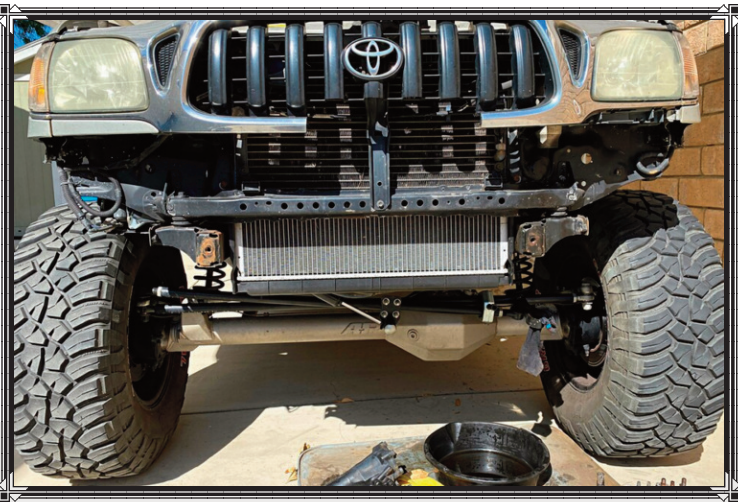
To make things easier for the steering box removal and to allow assessment of the frame and mounting hardware, we removed the Tacoma's aftermarket front bumper.

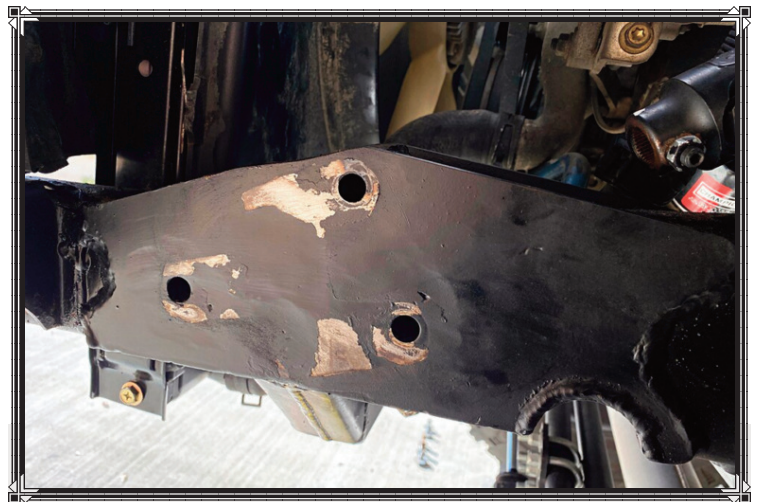
With the steering box removed it was a good time to completely flush and clean all of the caked-on steering fluid from the frame and box mounting area.

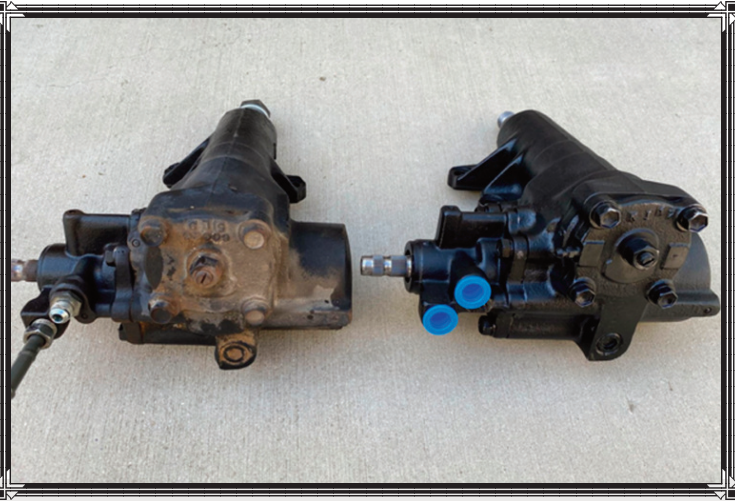
The professionally remanufactured Toyota power steering box shown is available from Yotamasters, and it looks as if it came straight from the factory. We compared both steering boxes to make sure that all dimensions were the same, and then we transferred both high-pressure and low-pressure hose fittings to the new steering box.

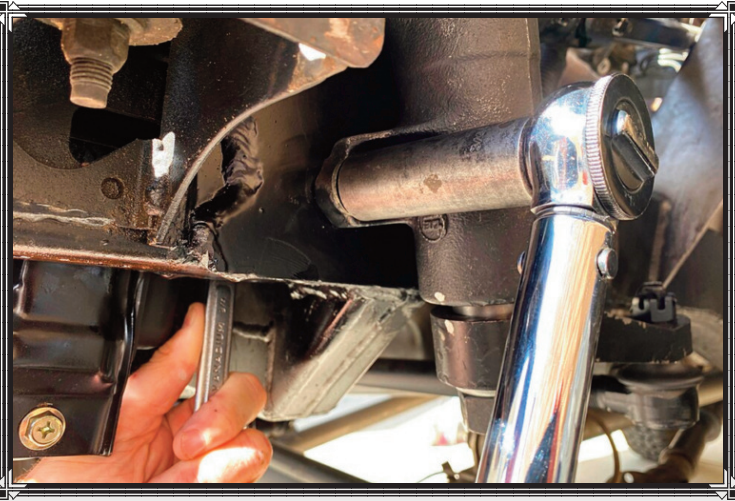
Mounting the new steering box was fairly straightforward. Tip: Make sure to use new hardware whenever possible. In our case, the bolts looked to be in great shape, so we simply replaced the Stover lock nuts and torqued them to spec.

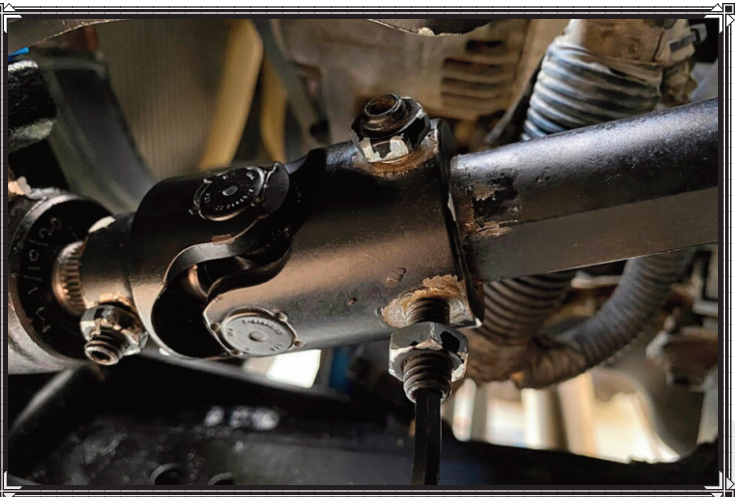
Once the steering box was in place, we were able to push and slide the steering shaft up toward the firewall enough to get it back onto the splines and then slide down to the set pin position. We reinserted the long pin/screw and then set and tightened all bolts.

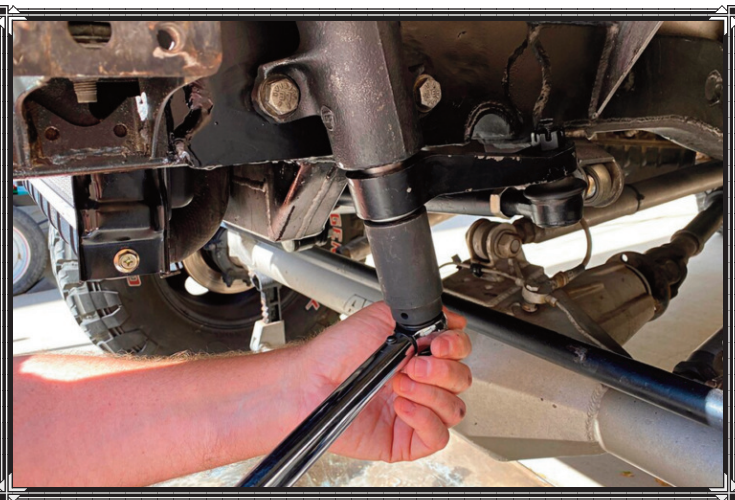
We then installed the pitman arm to the recommended torque spec. We used a new lock washer to keep the nut from possibly loosening up. It's important to check the steering box mounting bolts and pitman arm fasteners after 500 miles or so to make sure all are still tightened to spec.

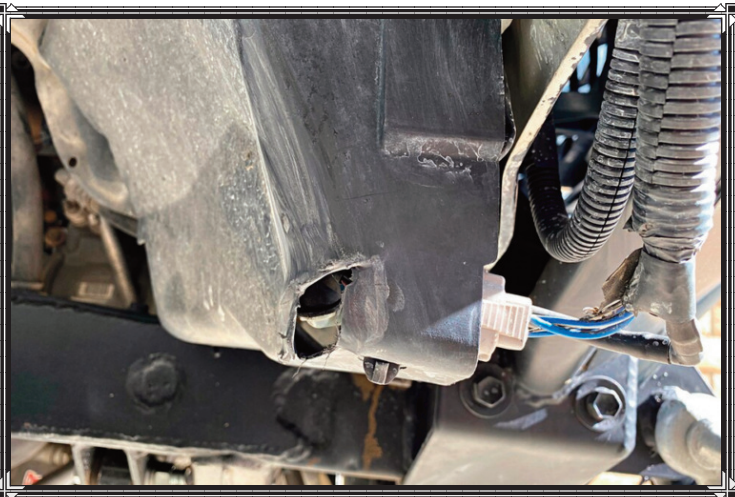
Moving on to the tire clearance list, the first order of business was this lower windshield washer plastic cover in the front passenger wheelwell area. It was slightly contacting the 35s, so we knew it was going to need to be addressed due to the larger 37s.

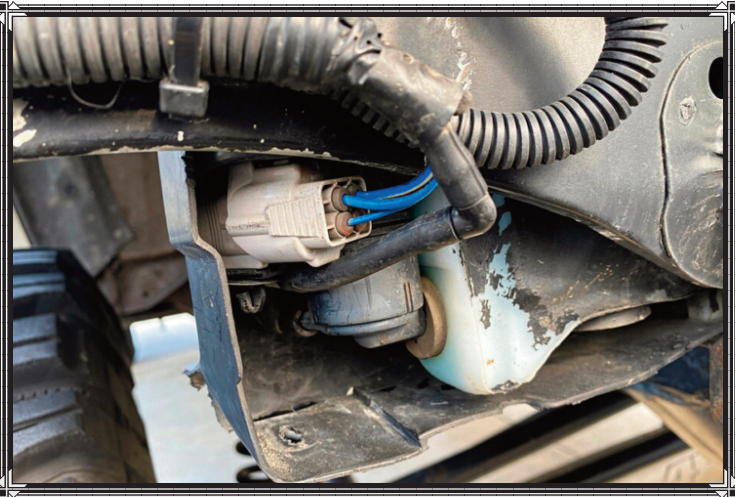
Relocating the wiper fluid motor plug and draw line up several inches as shown did the trick. This was easily done by shortening the line and using a zip tie to hold up the plug. We then cut the plastic for maximum clearance and will re-cover the area later.

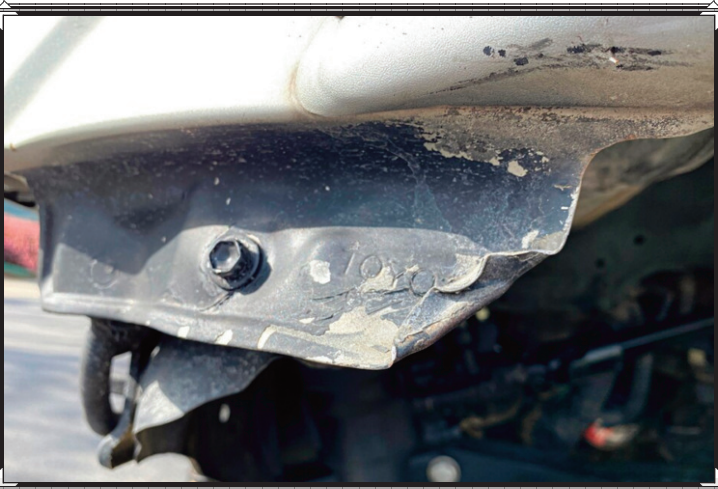
With the front bumper removed, we noticed there was plenty of useless sheetmetal located just behind the area of the front bumper wraparound, so we took the opportunity to generously trim the excess on both sides.

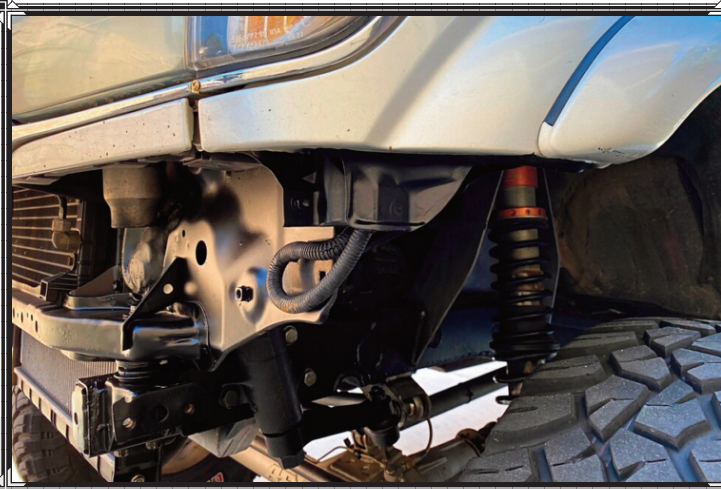
Once all the sheetmetal was removed with tin snips, there is now less risk of it cutting into the new 37s at full articulation. We also found this to be a good time to remove some surface rust areas and touch up the front core support and frame horns with some paint.

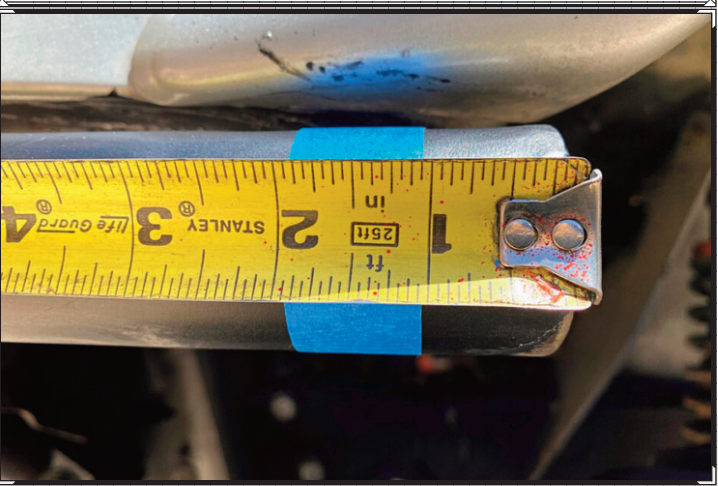
The old 35-inch front tires had been rubbing the very end of the front bumper wraparound, so we removed 1 inch at each end of the bumper knowing the larger tire radius is about 1 inch.

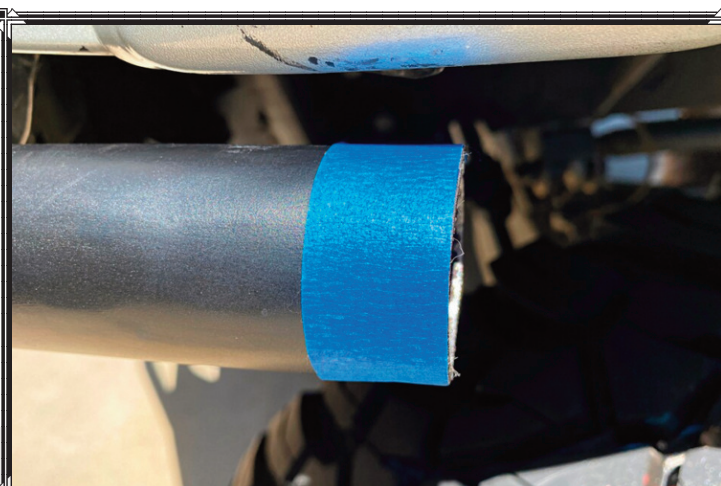
With the bumper cut 1 inch at each end, we then deburred and painted each end. We installed 1.5-inch temporary end caps until we could see if it would interfere with the new tires before welding in the new end caps.

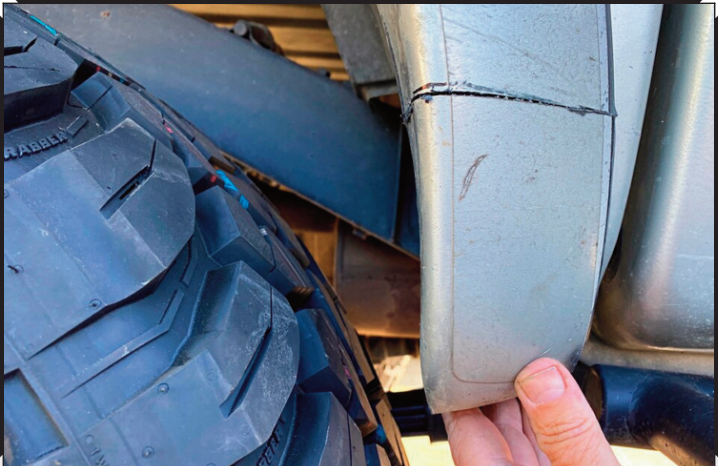
Moving to the rear of the Tacoma, we knew the factory fender flares were going to be an issue. With the old 35s we were able to get away with only slightly modifying the rear of the flare since the spring shackle and axle all flex rearward. But with the 37s nearly hitting the front at static ride height, it was time to cut.

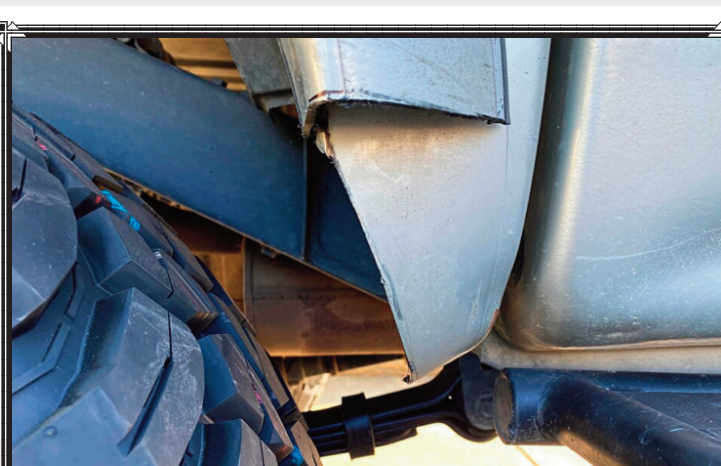
In an effort to not remove the entire fender flare as a lot of folks do when going to 37s and wanting to retain some tire coverage, we cut the flare on both the front and rear of the opening. We then used a cutoff wheel to trim and contour the sheetmetal to the tire as shown to improve clearance.

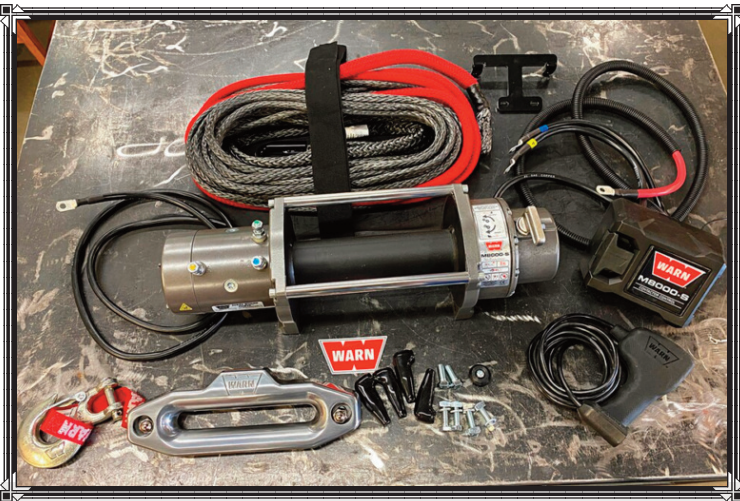
As mentioned, Warn has been our go-to winch for over 30 years for good reason. Shown here is our Warn M8000-S. It has a 4.8-hp motor, 216:1 gear ratio, 100 feet of 3/8-inch Spydura synthetic rope, a Hawse fairlead, and a remote control with 12-foot lead.

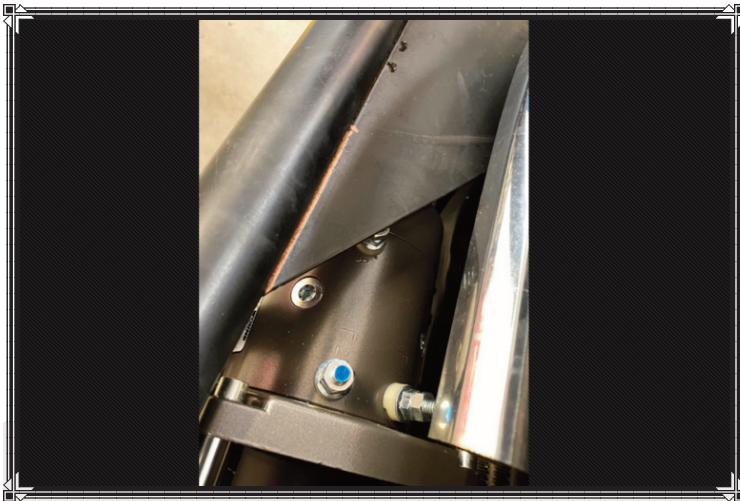
Our first hurdle fitting the new Warn winch on the existing after-market bumper was that the top cover plate made contact with one of the power terminals.

Mike Duval of Duval Offroad Design made quick work by marking the plate where it needed to be removed equally on both sides and then cutting out the offending metal. Next, he added a control box mount tab angled back on the front of the bumper since the box would not fit on top of the winch without cutting the grille even more than it already had been for the last winch.

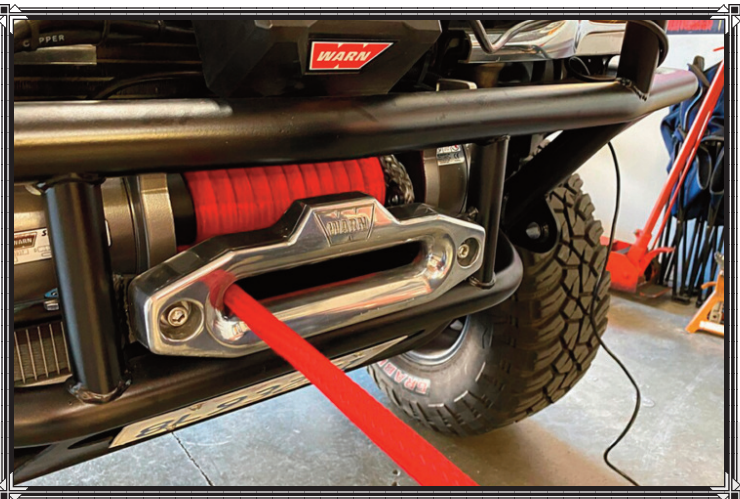
With the front hook installed and the red part of the rope securely screwed to the winch drum, we installed the rope per the included instructions to get it spooled the correct way. If done incorrectly the synthetic line can be damaged when you need to use the winch with extreme line tension.

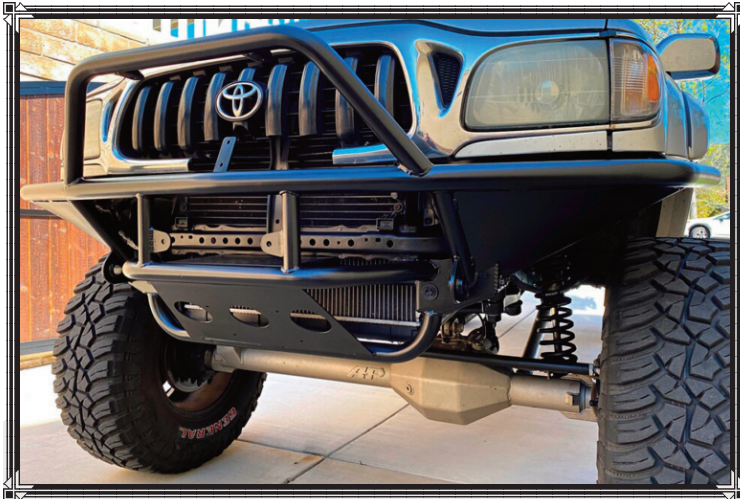
Here you can see the custom winch control box mount tab Duval welded onto the bumper. We also used this time to completely paint the bumper after all the necessary modifications.

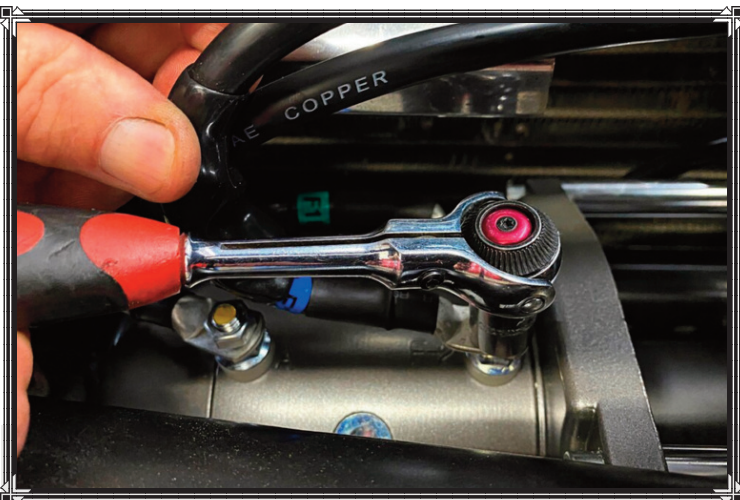
Once the winch was installed onto the bumper with the four main mounting bolts, we installed the bumper and winch as a unit, feeding the wires to the necessary locations until it was bolted up. We then connected the color-coded terminals from the control box to the winch, along with the power and ground connections.

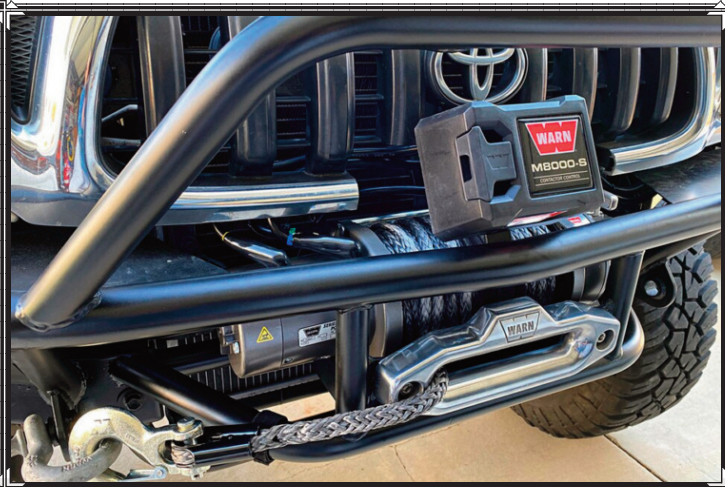
Shown here is the completed winch install with the control box up and out of harm's way. Having the control box mounted in this location also aids when someone is helping you with the recovery so they do not have to search for a hidden box with a difficult plug location.

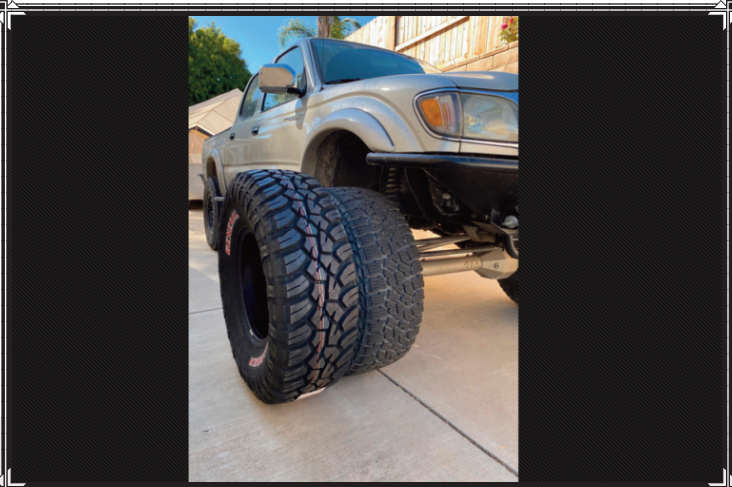
Here's the side-by-side comparison between the 35s mounted on the truck and the 37s upon arrival. It looked substantial, and we wondered if the fitment mods would actually be enough!

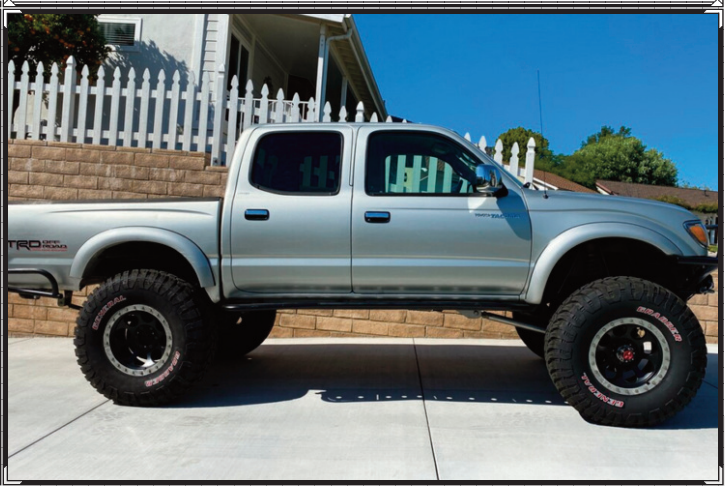
Here's how the truck looks at static ride height once everything was installed and modified to fit the 37-inch General Grabber X3s. Our Tacoma now looks way more proportional and should perform better on the trails, as well.

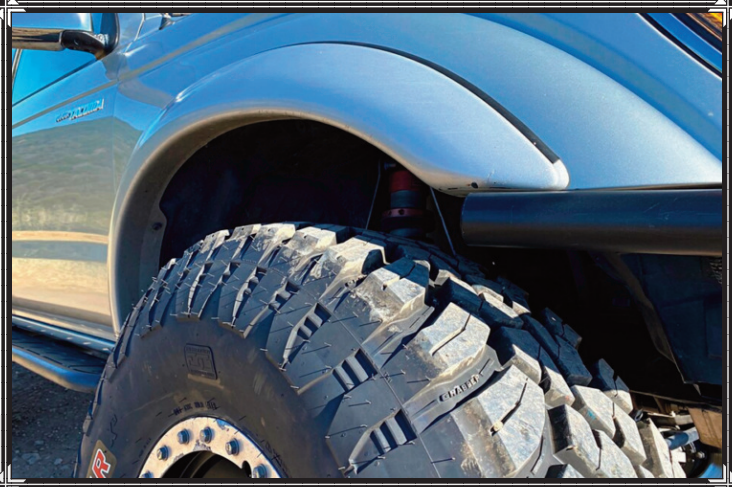
Although the 37-inch tire cleared the front bumper end and flare in this photo, the obstacle probably only utilized 85 percent of the suspension travel, so we anticipate some contact on tougher terrain, and we may need to make more modifications. Out of view here, the rear of the front fender flare was not making any contact, but could slightly as the wheel is turned while navigating certain obstacles.

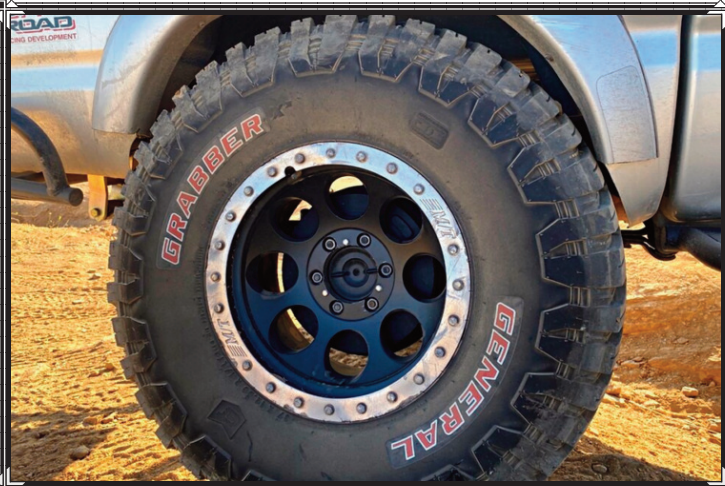
With the new 37s mounted and modifications complete, it was time to hit the trail and test on some obstacles to see just how the tires would clear. Shown here is the rear at decent flex with the tire easily clearing the sheetmetal and barely missing the flare.
